Hong Kong Offshore LNG Terminal Project

Annual Environmental Monitoring and Audit (EM&A) Review Report for October 2021 to September 2022

1 December 2022

Project No.: 0505354

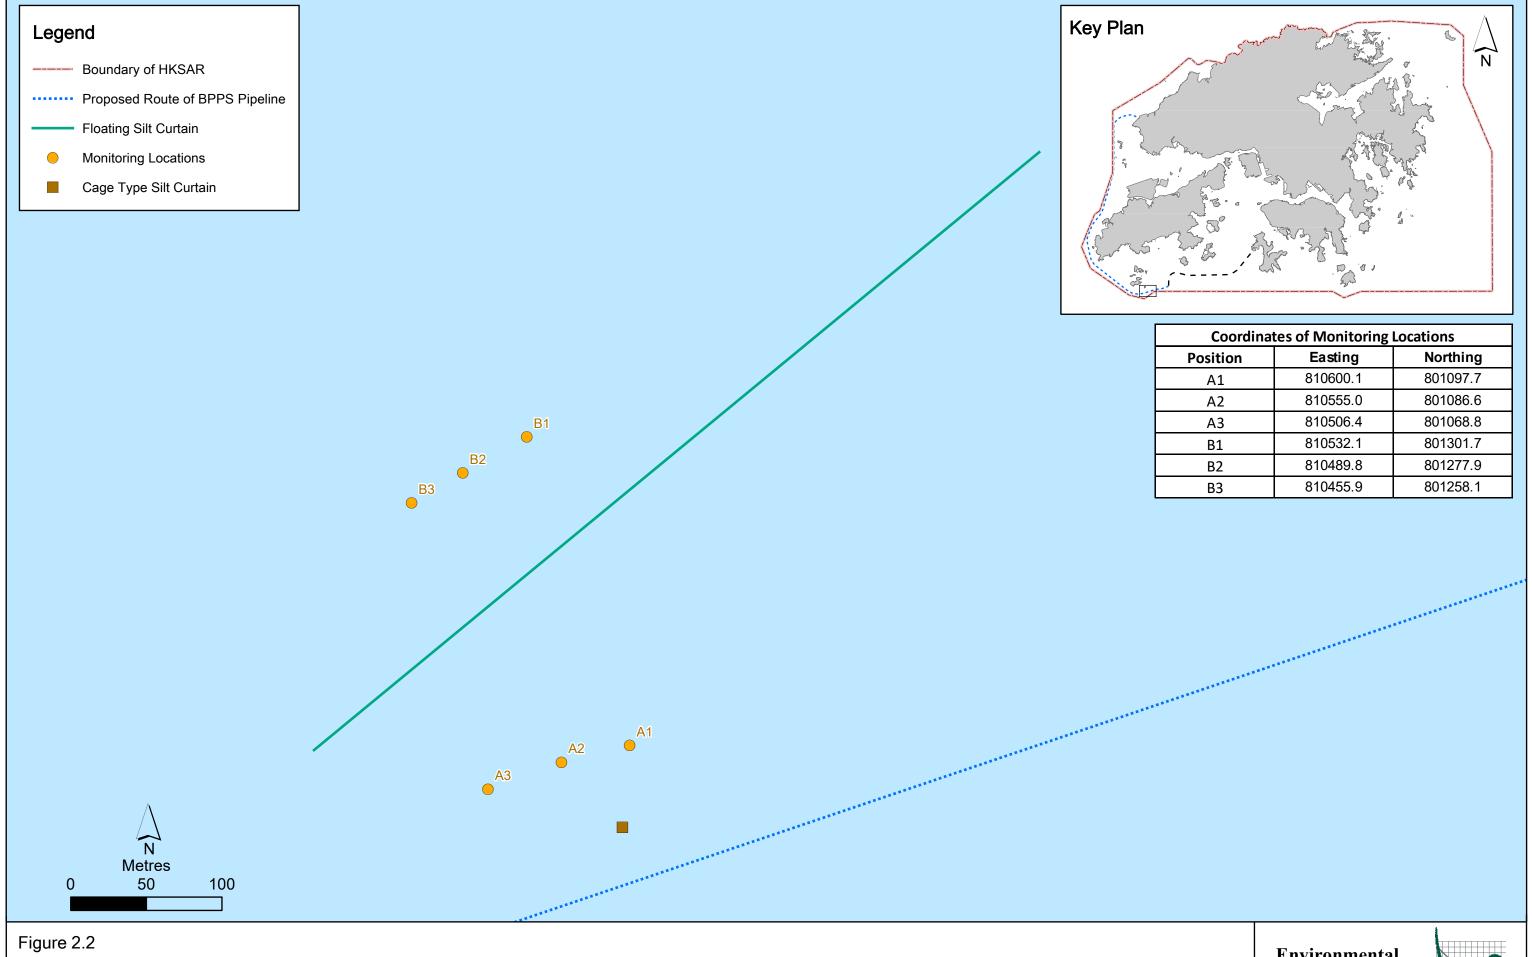
Monitoring Locations for Floating Silt Curtain Pilot Test for Jetting Operation

The monitoring results of the pilot tests are summarised in *Table 2.9*, showing that the efficiencies range from 87.64% to 92.05% with an average of 90.08% which is greater than the EIA assumption of 80% for floating silt curtain at sensitive receivers. The results of the pilot test have demonstrated that the tested silt curtain system is capable of achieving an efficiency greater than that assumed in the approved EIA Report. As such, the proposed floating silt curtain is effective for the jetting operation for the Project to minimize water quality impacts and no further measures/ recommendations are required. As similar floating silt curtain and jetting machine are used for the construction of the BPPS and LPS Pipelines, this pilot test results of floating silt curtain for jetting works are applicable for the subsea gas pipeline for BPPS under FEP-03/558/2018/B and the subsea gas pipeline for LPS under FEP-02/558/2018/A.

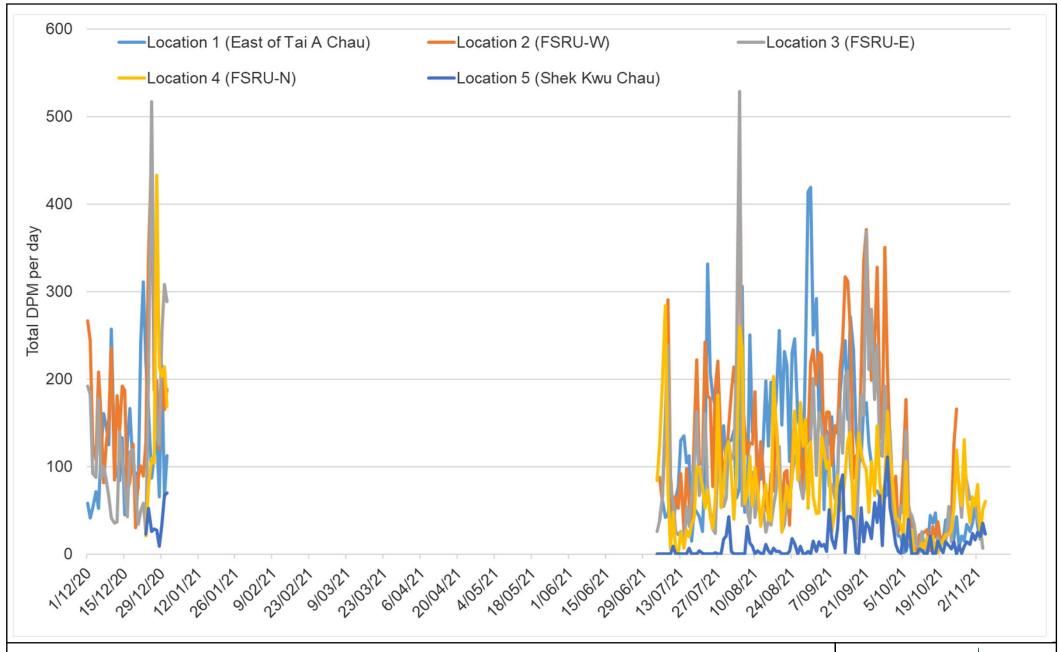
Figure 2.7 Detection Positive Minutes (DPM) per Day for Finless Porpoises among the Five Deployment Locations during the period of piling works of the Project

Variations in porpoise activity per day were observed at all five locations during the period of piling works of the Project in December 2020 and in July 2021 to early November 2021 (see Figure 2.7). The mean porpoise DPM per day at the five locations ranged from 14.9 (Location 5) to 137.9 (Location 2) for the analysed period. Location 5 (Shek Kwu Chau) recorded the least porpoise activity amongst the five locations. Further analysis will be conducted to compare the finless porpoise detection numbers between the baseline, construction and post-construction monitoring upon completion of the post-construction monitoring.

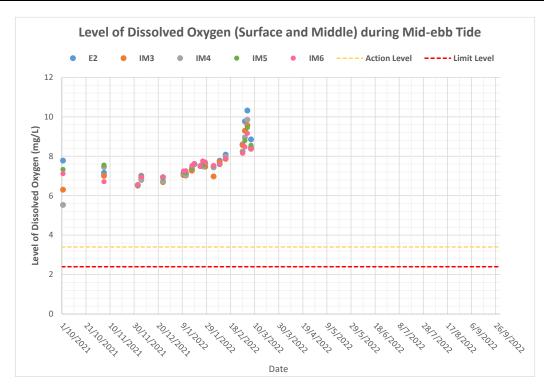
Figure F1a: Levels of Surface and Middle Dissolved Oxygen (mg/L) at control station (E2) and impact stations (IM3-IM6) under Group 2 during mid-ebb tides between October 2021 and September 2022

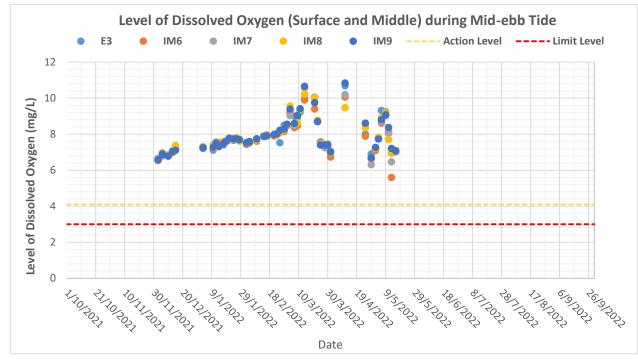
Figure F1b: Levels of Surface and Middle Dissolved Oxygen (mg/L) at control station (E3) and impact stations (IM6-IM9) under Group 3 during mid-ebb tides between October 2021 and September 2022

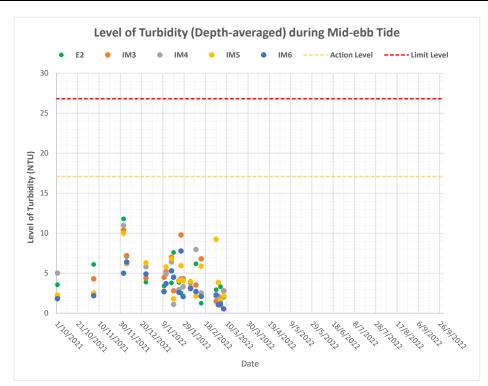
Figure F3a: Levels of Depth-averaged Turbidity (NTU) at control station (E2) and impact stations (IM3-IM6) under Group 2 during mid-ebb tides between October 2021 and September 2022

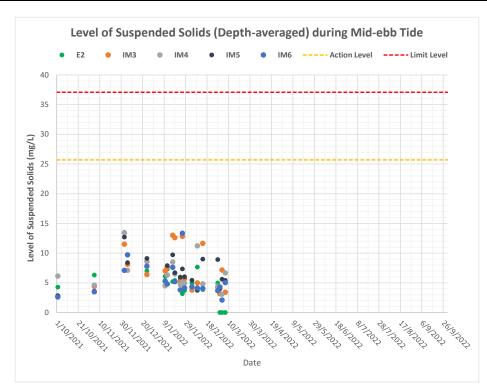
Figure F4a: Levels of Depth-averaged Suspended Solids (mg/L) at control station (E2) and impact stations (IM3-IM6) under Group 2 during mid-ebb tides between October 2021 and September 2022
